# Rock Hog Problem Solver Manual

Manual No. 49004

## **Button Breaks**

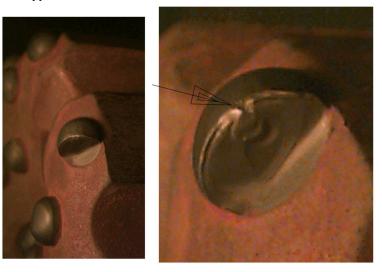
Shown here is a classic overload break. The button is not dull but was still stressed to the point of failure. The exact point of where the overload stress was applied is visible.

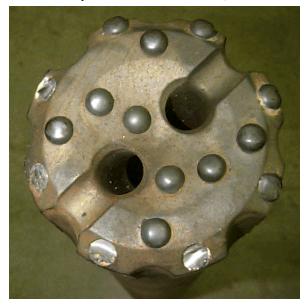
Another instance where buttons become overloaded is when the bit is put into an existing hole that is smaller than the gage size of the bit such as when drilling an old well deeper or using undersize casing. In this case, high loads are applied on the outer edge of the button.

Note that the peak runs with the rotation, not across the rotation

Normally there is an abnormal wear pattern visible on the outer edge of the gage buttons

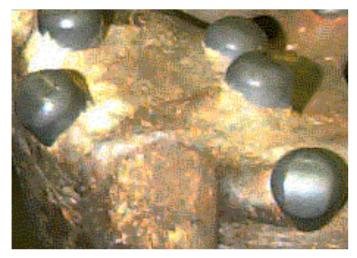
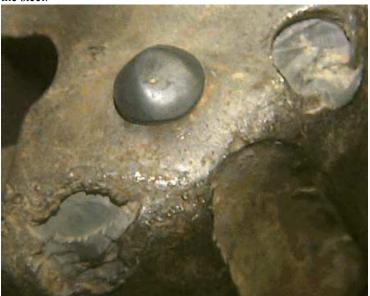
**Loss of steel support** Some formations drilled will wear away the steel body much faster than the buttons. In this situation, the buttons will eventually be standing out so far that they break or shear off.

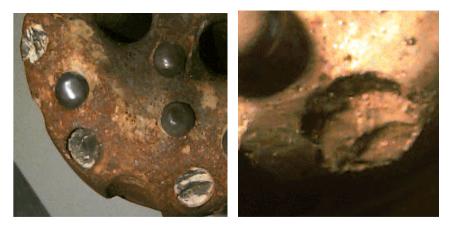
Shear breaks usually have an erratic pattern on the failed surface. Normally the inside edge will be broke under the steel while the outside edge is broke down to the steel.

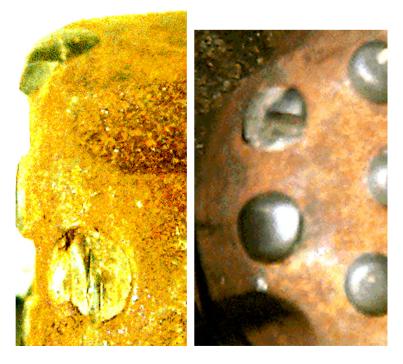
**Loss of carbide support** Some formations drilled will wear away the buttons at a rapid rate, while the steel does not wear. In this situation, the buttons will eventually be worn down to the steel forming a button with a very weak profile.
